## SWAG 40 93 3044

to fit:  
Opel 2.0l turbo and 2.2l petrol engines

## Chain tensioner

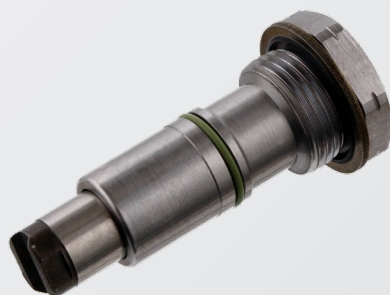
A blocked timing chain tensioner. The original version (repl. no. 0636549) of the chain tensioner had a green O-ring and a rubber-lined washer (see Fig. 1). The vehicle manufacturer fitted this version in the engines mentioned above. A modified chain tensioner has been used in production since model year 2009.

Old

New

SWAG recommends using only the new chain tensioner SWAG 40 93 3044 (repl. no. 4807 839). This is provided with a rubber-lined metal washer under the head (see Fig. 2). This ensures perfect guidance of the timing chain.
