## SWAG 40 93 3044

to fit:  
Opel 2.0l turbo and 2.2l petrol engines

## Chain tensioner

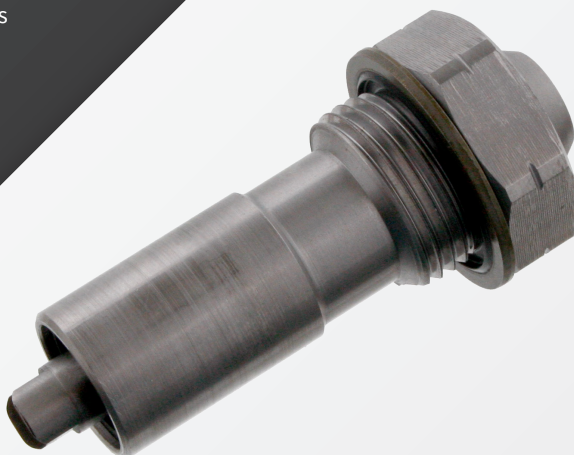
Although all the components have been correctly fitted, rattling noises are often present (caused by the elongation of the timing chain). If the timing chain slips as a result, then the engine can run erratically and misfire and in the worst case cause extensive engine damage. This affects Z22YH and Z22SE engines.

A blocked timing chain tensioner. The original version (repl. no. 0636549) of the chain tensioner had a green O-ring and a rubber-lined washer (see Fig. 1). The vehicle manufacturer fitted this version in the engines mentioned above. A modified chain tensioner has been used in production since model year 2009.

SWAG recommends using only the new chain tensioner SWAG 40 93 3044 (repl. no. 4807 839). This is provided with a rubber-lined metal washer under the head (see Fig. 2). This ensures perfect guidance of the timing chain.

We always recommend that a new timing chain (SWAG 40 93 3043 repl. no. 5636 396) is fitted when replacing the chain tensioner. Both components are included in the chain kits SWAG 99 13 3042 (fits Z22YH) and SWAG 99 13 3045 (fits Z22SE)!

To prevent the timing chain from skipping when the engine is running, the chain tensioner should not be brought into the working position until the chain has been fitted. Please refer to the attached Info for details.
